TECHNICAL NOTE

Controlling the propeller hub for the DUC Flash II, Flash II LBT and Flash-Back PV, and mounting of a spacer.

1st June 2016

SB-JRO-912-914-003

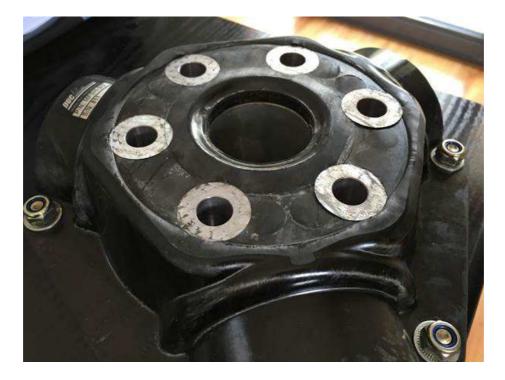
We noticed, on a few recent propellers of this kind, a deformation of the surface of the carbon forged face of the hub in contact with the driving pulley (SEE example on photo paragraph 3), and an exaggerate free play between the aluminum centering pins and the carbon. The depth of this deformation is variable : from a simple scratch to a 1.5mm recess

Even a light recess of the carbon half hub can lead to the progressive loosening of the fixing bolts, as well as abnormal vibrations.

Note : Example of a very importante recess, meaning the replacement of the half hub.

⇒ When in doubt, please send us a good quality photo : After expertize, we can eventually send you a replacement half hub
