## INFORMATION BULLETIN

Bulletin n°05-2005 - Level : =>

### Correct Installation of the Kuntzleman Strobe (SC 103)

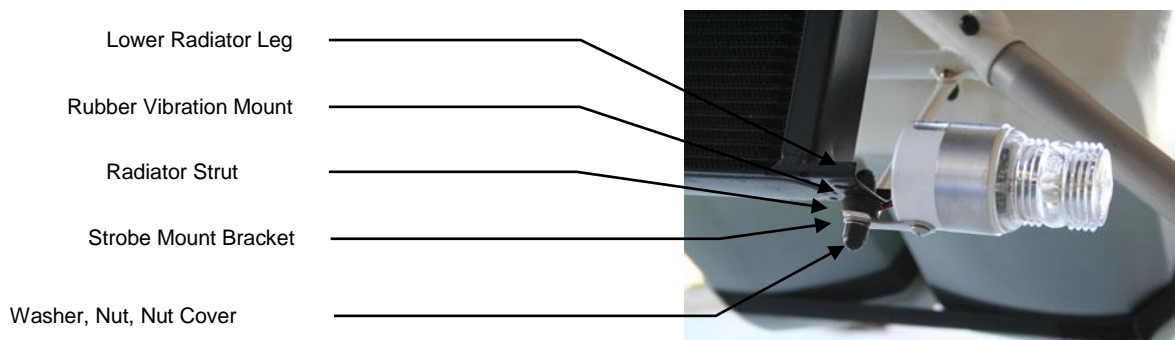
Illustration A

**Problem:** On two (2) aircraft, a fracture of the lower radiator strut as been observed upon which a Kuntzleman strobe was attached.

**Cause:** Incorrectly installed and situated strobe mount.

**Note:** Observe the stacking order illustrated in the photograph below.

**Solution:** The strobe must be installed **UNDER** the radiator strut (See Illustration A).

**Reminder:** The strobe's stainless attachment bracket angle **MUST** not be changed; it is imperative that the cap screw **NOT** be loosened. This screw also fixes the internal board which contains the electronic components.
