# TECHNICAL NOTE

## Replacing pre-rotating ring gear screws

- **Date** : May 28<sup>th</sup> 2018
- **Impacted aircrafts** : J-RO and XEELEEX from #001 till today and delivered rotor-head up till today
- **Application** : immediately
- **Motivation** :  
Following a faulty screw supply, some DG910-10 (Ring gear disk and pre-rotator ring gear) has been assembled with a wrong kind of screw. For safety reasons, the supplier advise the replacement of all potentially concerned screws (please report to "Impacted Aircraft" section above)
- **Object** :  
Replacement of the pre-rotating ring gear screws
- **Risks** :  
Screws can be overload and can lead to a major failure of the screw (breaking)

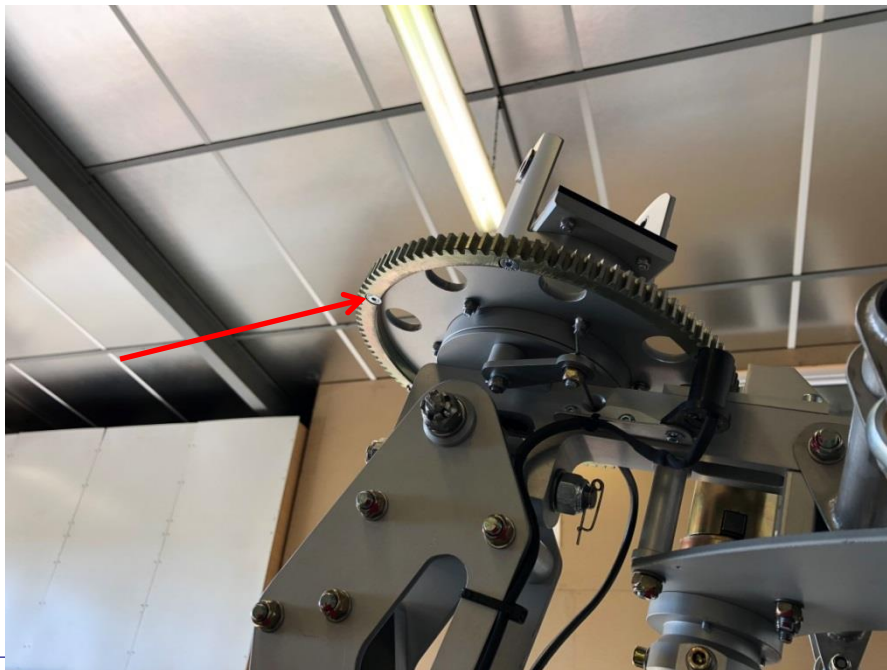
- ⇒ Loose each one of the 6 M5 screws on the outside of the diameter
- ⇒ Take out one screw and put it aside
- ⇒ Apply threadlocker on a new screw (sent by DTA) and screw it in place
- ⇒ Tightening torque : 6 Nm
- ⇒ Repeat operations on each one of the 6 concerned screws

- ⇒ Check the tightening torque on the 6 replaced screws
